PTPT REPORT NO. 78-12 AFPEA PROJECT NO. 77-P7-55

PERFORMANCE EVALUATION OF A POLYETHYLENE FOAM SHIPPING CONTAINER FOR THE F-16 EMERGENCY POWER UNIT HYDRAZINE FUEL TANK

> HQ AFALD/PTP AIR FORCE PACKAGING EVALUATION AGENCY Wright-Patterson AFB OH 45433

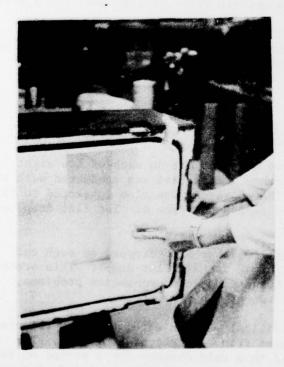
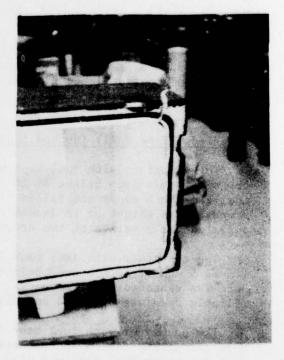
FIGURE 4.

Low temperature drops  $(-40^{\circ}\text{F})$  from 18 inches resulted in significantly increased shock transmission as well as container damage.

The container was inspected after each series of drop tests. The container was damaged during the low temperature corner drop tests (Figures 4 and 5). The polyethylene material separated, damaging the gasket seal in two places. The separation was in the form of a material failure rather than that of a glue joint. The damage was attributed to the rigidity of the material at low temperature.

Container damage resulting from the 18" low temperature corner drops.

- a. Gasket seal be redesigned to maintain the prescribed 1.0 psig pressure.
- b. Investigate a new molding process for polyethylene material developed by Kaneka American Corporation, 1251 Avenue of the Americas, New York NY 10020.
